V.C. SUMMER NUCLEAR STATION

VISUAL IMPACT ASSESSMENT OF HISTORIC PROPERTIES

VCS2-Lake Murray 230 kV Line No. 2

VCS2-St. George 230 kV Line No. 1

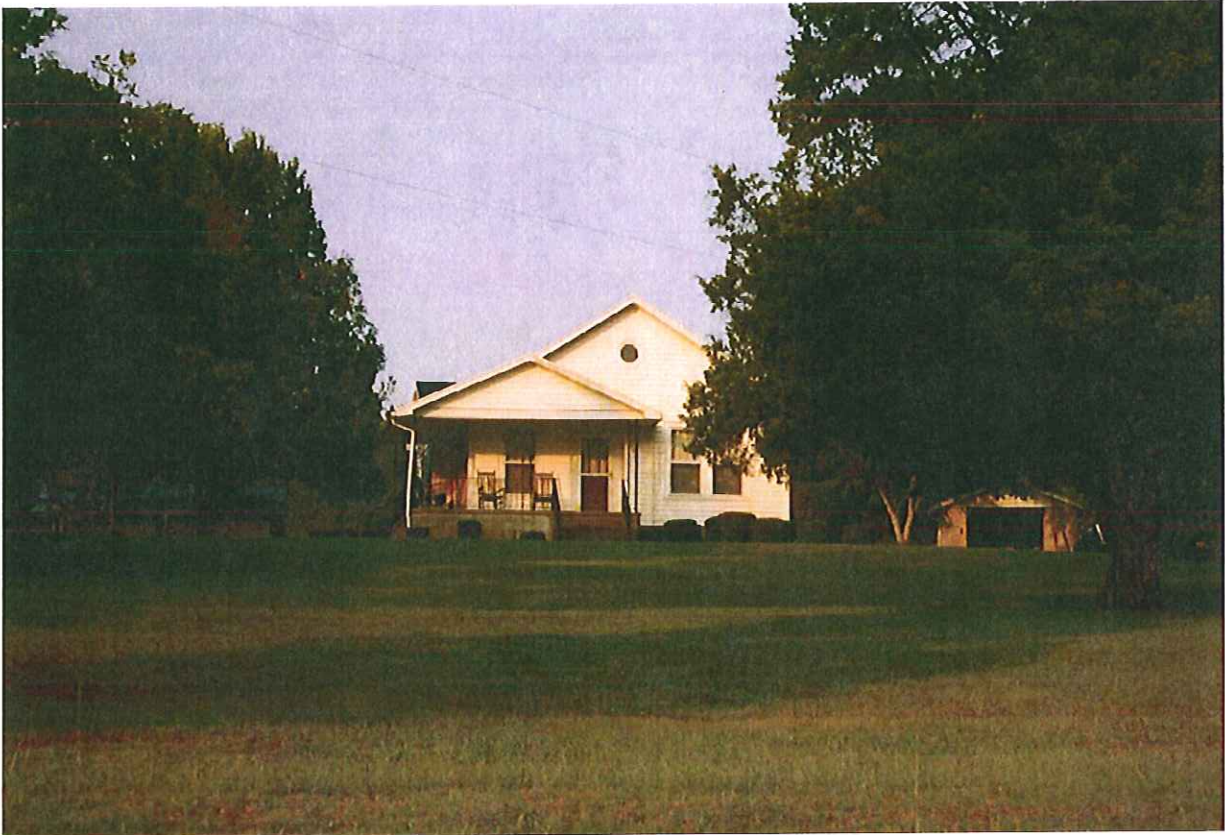
Historic Site: (BA Resource 5)

Description: White front-gable house with 3 outbuildings

Distance from Line Route: 1.12 miles / 1.8 kilometers

Field Visit & Analysis: Heavy foreground and mid-ground screening; line route will not be visible.

Conclusion Based on the Visual Impact Assessment and Field Visit: No View

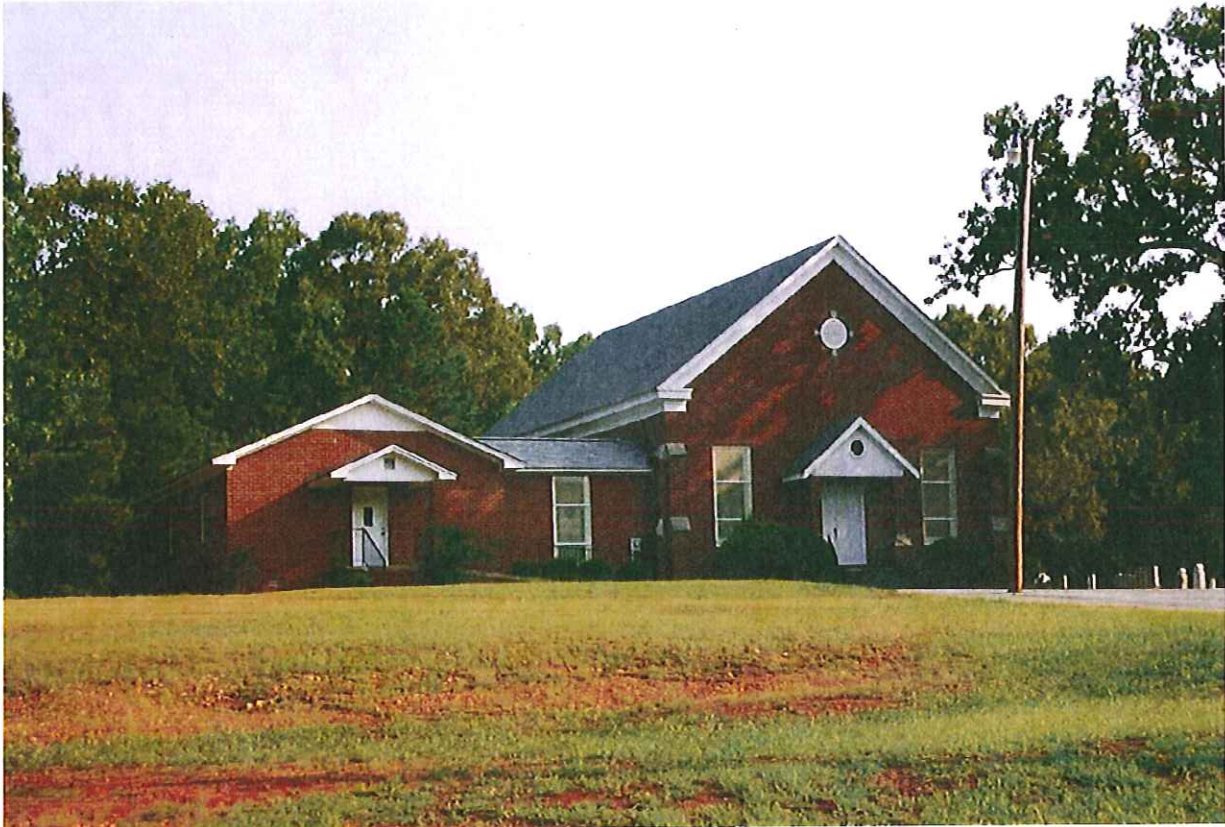
Historic Site: (BA Resource 7)

Description: Brick church remodeled in 1954; iron gate and archway, cemetery with markers ca. 1880's

Distance from Line Route: 0.66 miles / 1.06 kilometers

Field Visit & Analysis: Heavy foreground screening; line route will not be visible.

Conclusion Based on the Visual Impact Assessment and Field Visit: No View

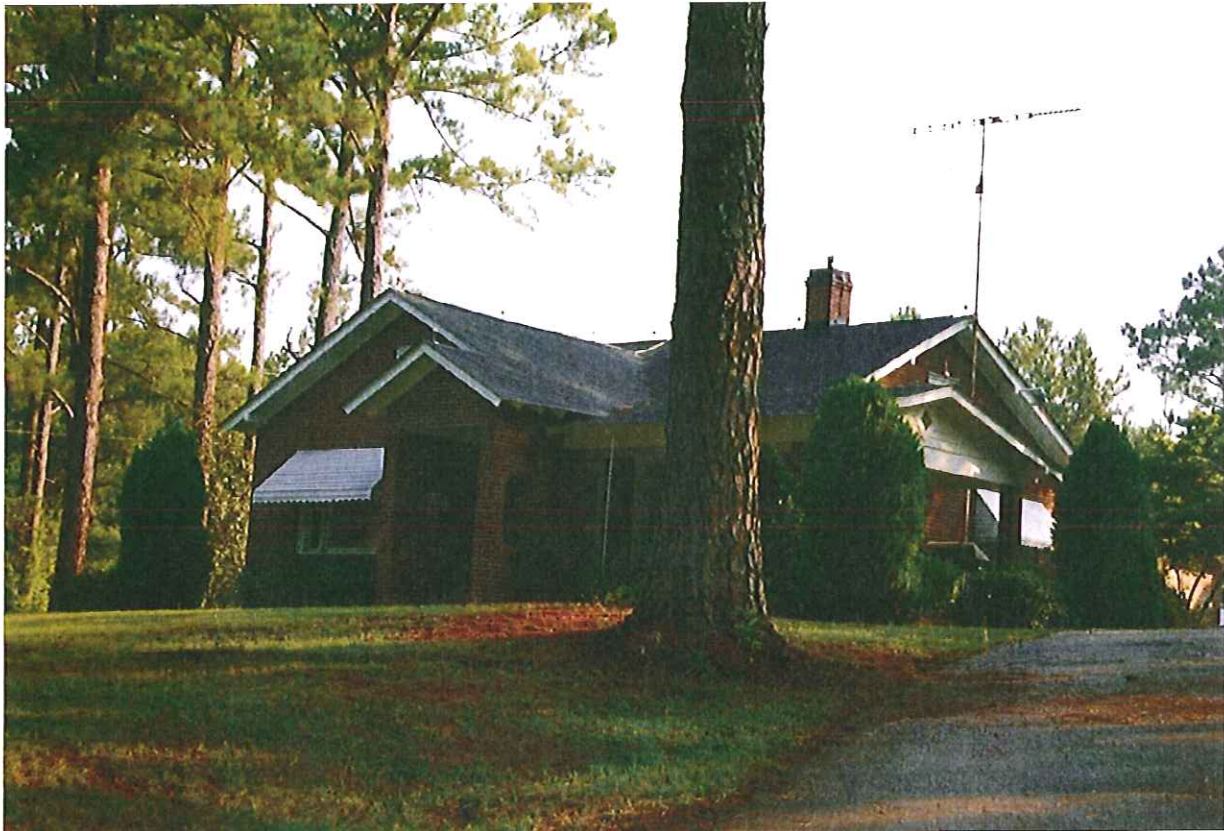
Historic Site: (BA Resource 9)

Description: Brick house with Tudor characteristics & multi-gable roof; rear addition with stone veneer

Distance from Line Route: 1.12 miles / 1.8 kilometers

Field Visit & Analysis: Heavy foreground screening; line route will not be visible.

Conclusion Based on the Visual Impact Assessment and Field Visit: No View

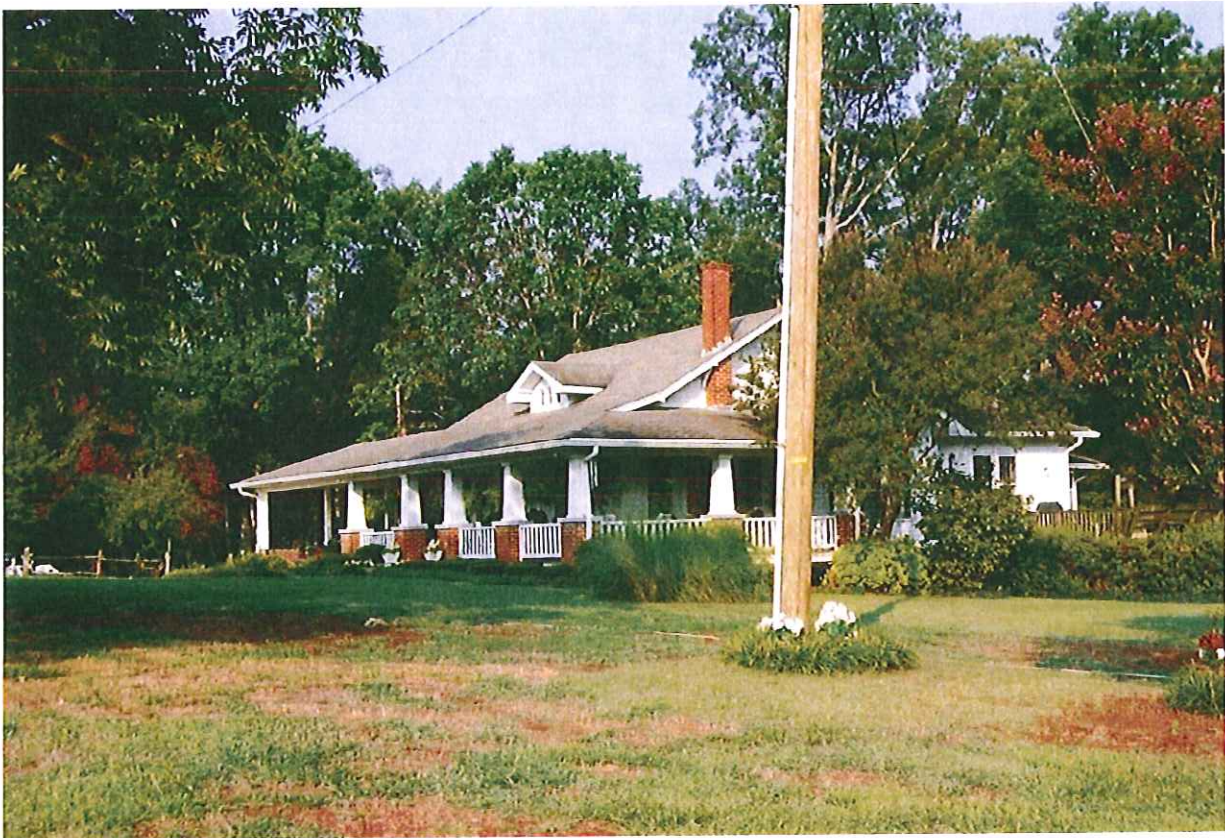
Historic Site: (BA Resource 11)

Description: White craftsman bungalow with possible new porch

Distance from Line Route: 0.53 miles / 0.86 miles

Field Visit & Analysis: Light foreground and heavy mid-ground screening; low probability of a view to line route.

Conclusion Based on the Visual Impact Assessment and Field Visit: No View

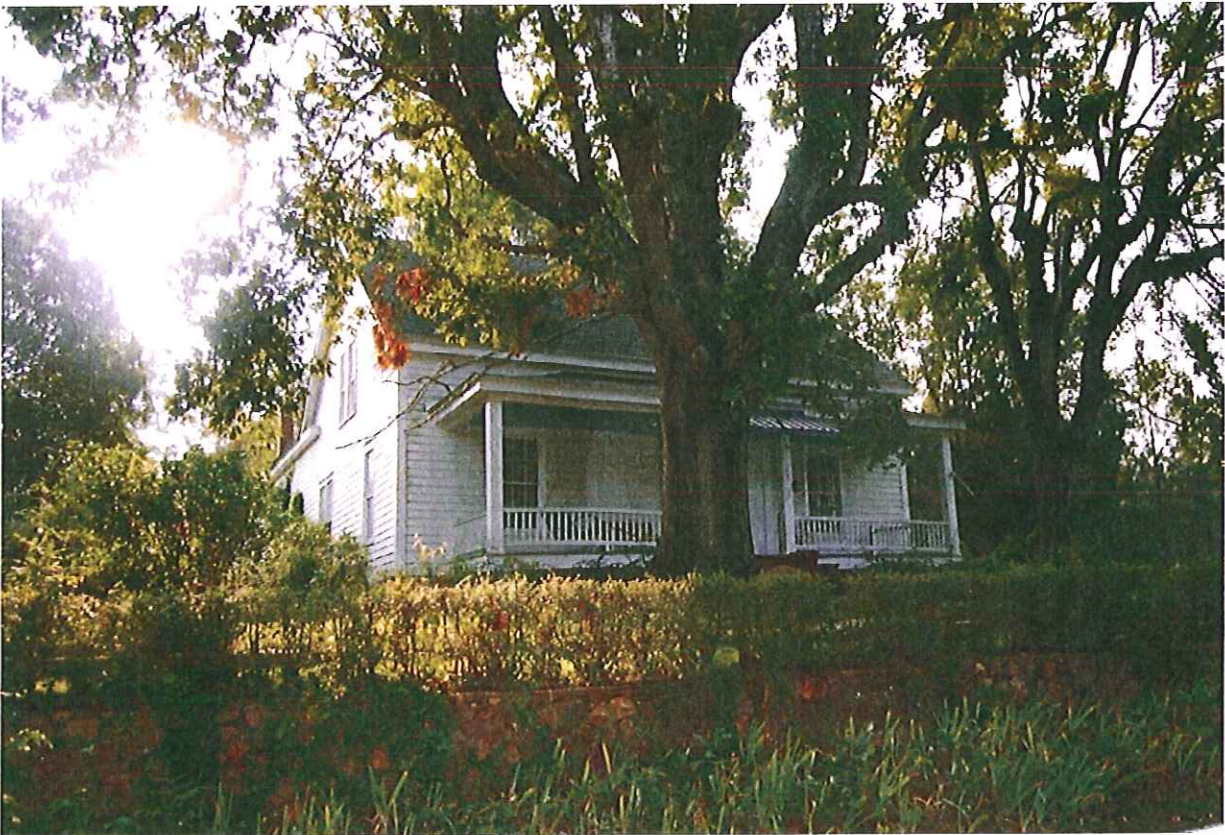
Description: White house with side-gable roof, brick foundation, original windows and siding

Distance from Line Route: 0.8 miles / 1.28 kilometers

Field Visit & Analysis: Heavy foreground and mid-ground screening; line route will not be visible.

Conclusion Based on the Visual Impact Assessment and Field Visit: No View

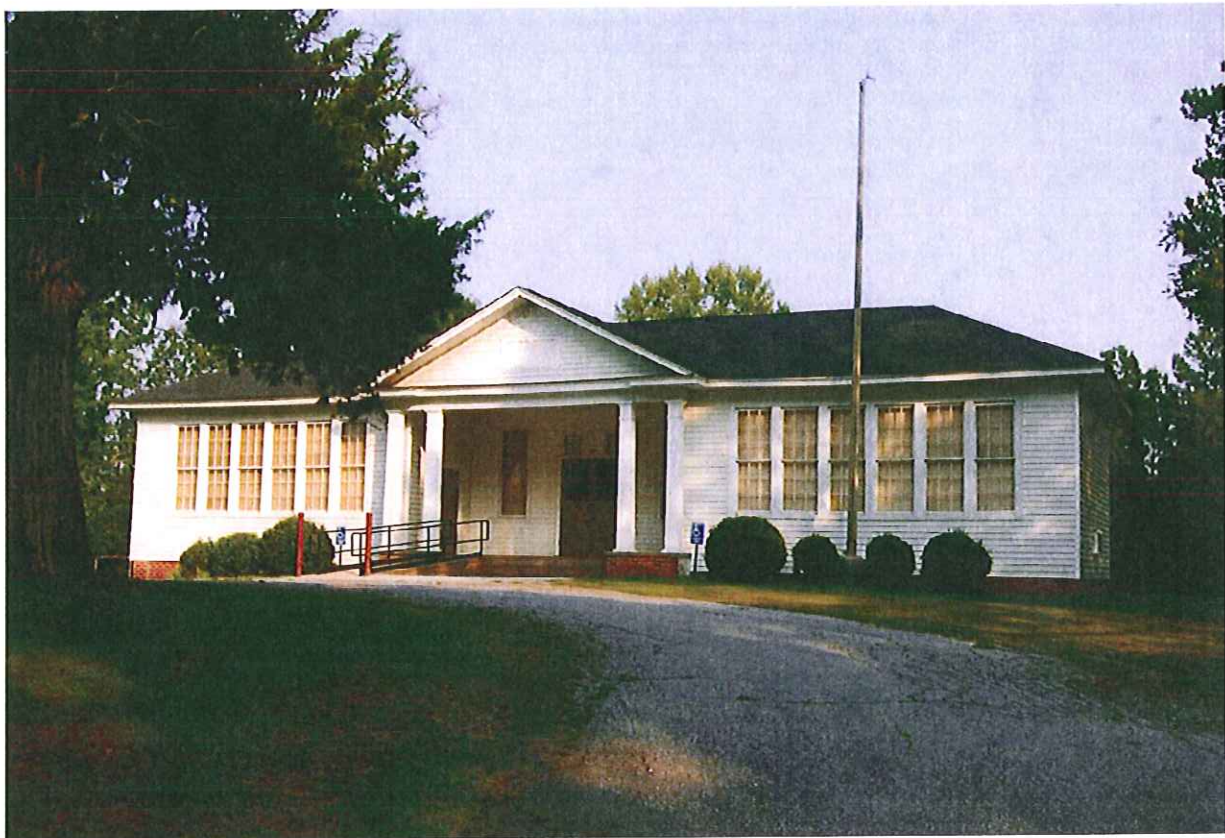
Historic Site: (BA Resource 13)

Description: White house; 9/9 wood frame; d-h windows; vinyl siding; brick foundation (filled-in)

Distance from Line Route: 0.69 miles / 1.1 kilometers

Field Visit & Analysis: Heavy foreground screening; line route will not be visible.

Conclusion Based on the Visual Impact Assessment and Field Visit: No View

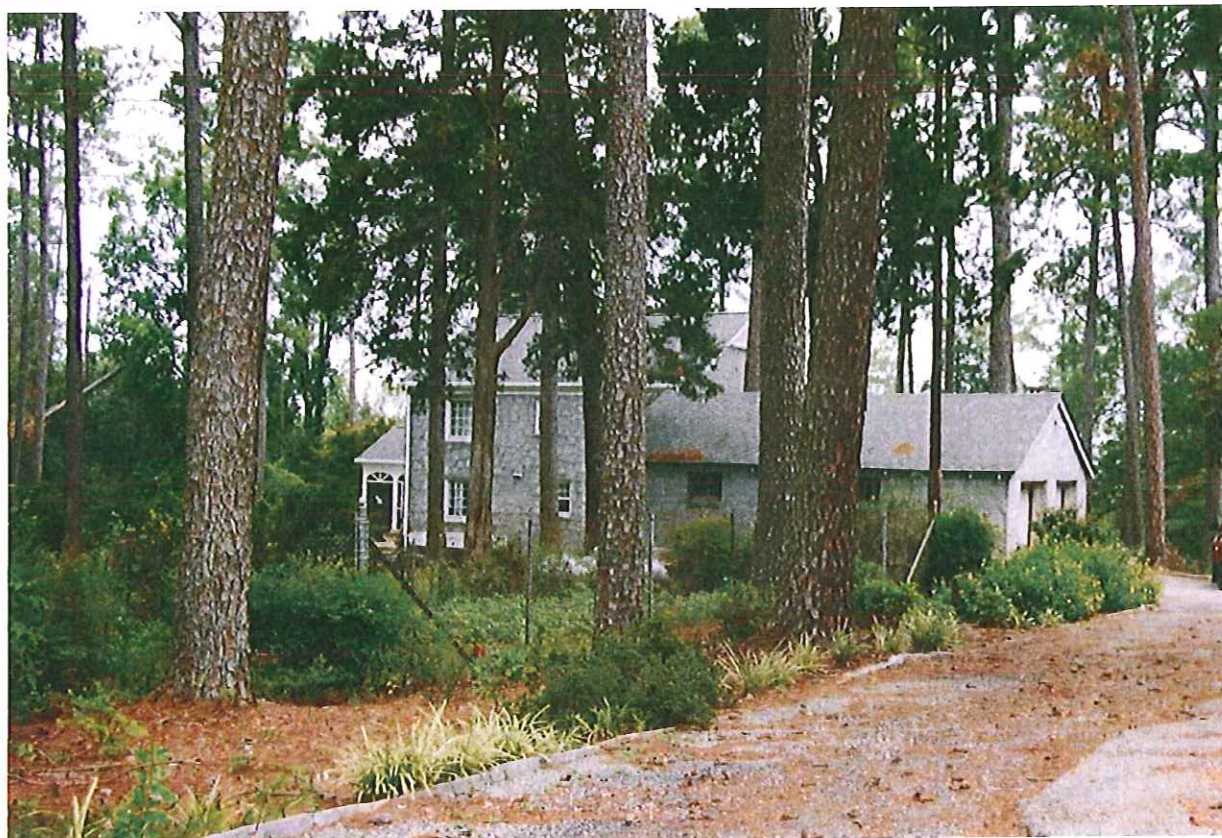
Historic Site: (BA Resource 14)

Description: Stone house with matching stone garage and walls

Distance from Line Route: 0.59 miles / 1.02 kilometers

Field Visit & Analysis: Heavy foreground screening; line route will not be visible.

Conclusion Based on the Visual Impact Assessment and Field Visit: No View

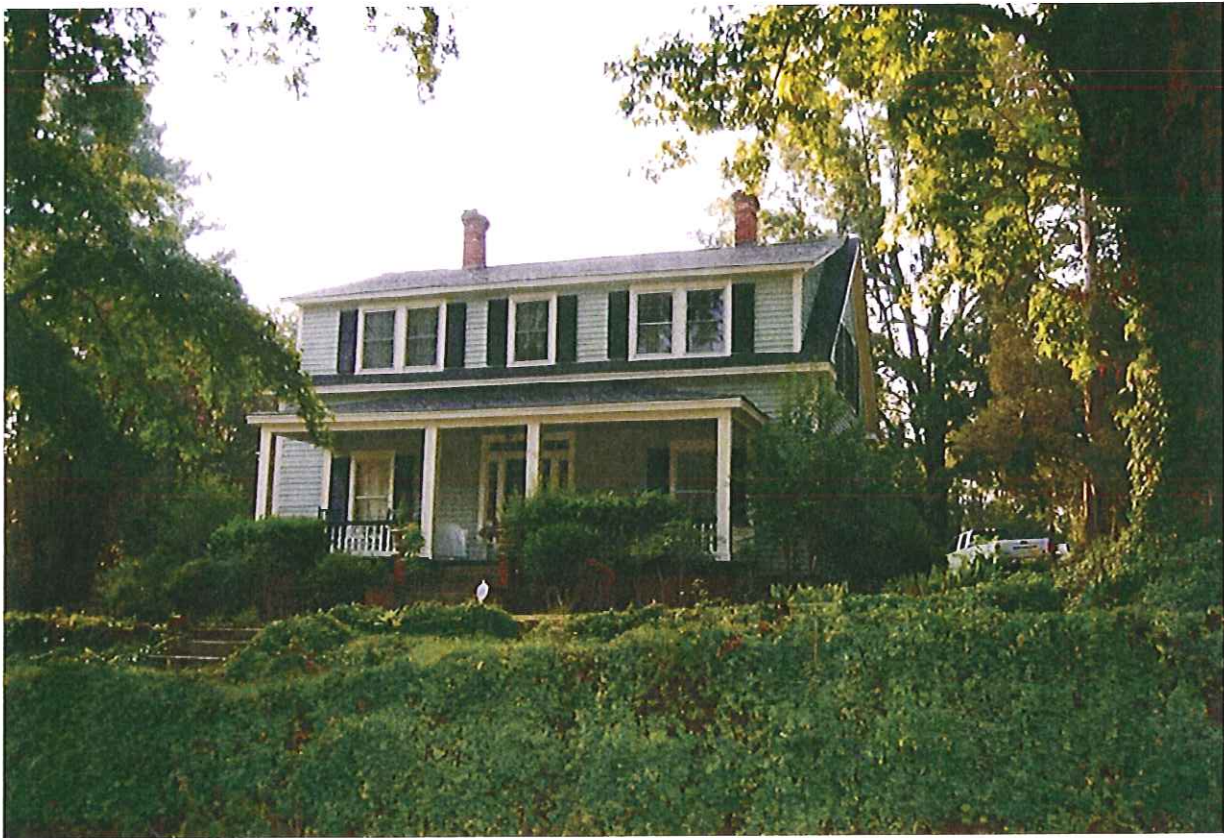
Historic Site: (BA Resource 15)

Description: Two-story green house with full-shed dormer; sidelights and transom; double chimney

Distance from Line Route: 0.8 miles / 1.26 kilometers

Field Visit & Analysis: Heavy foreground and mid-ground screening; line route will not be visible.

Conclusion Based on the Visual Impact Assessment and Field Visit: No View

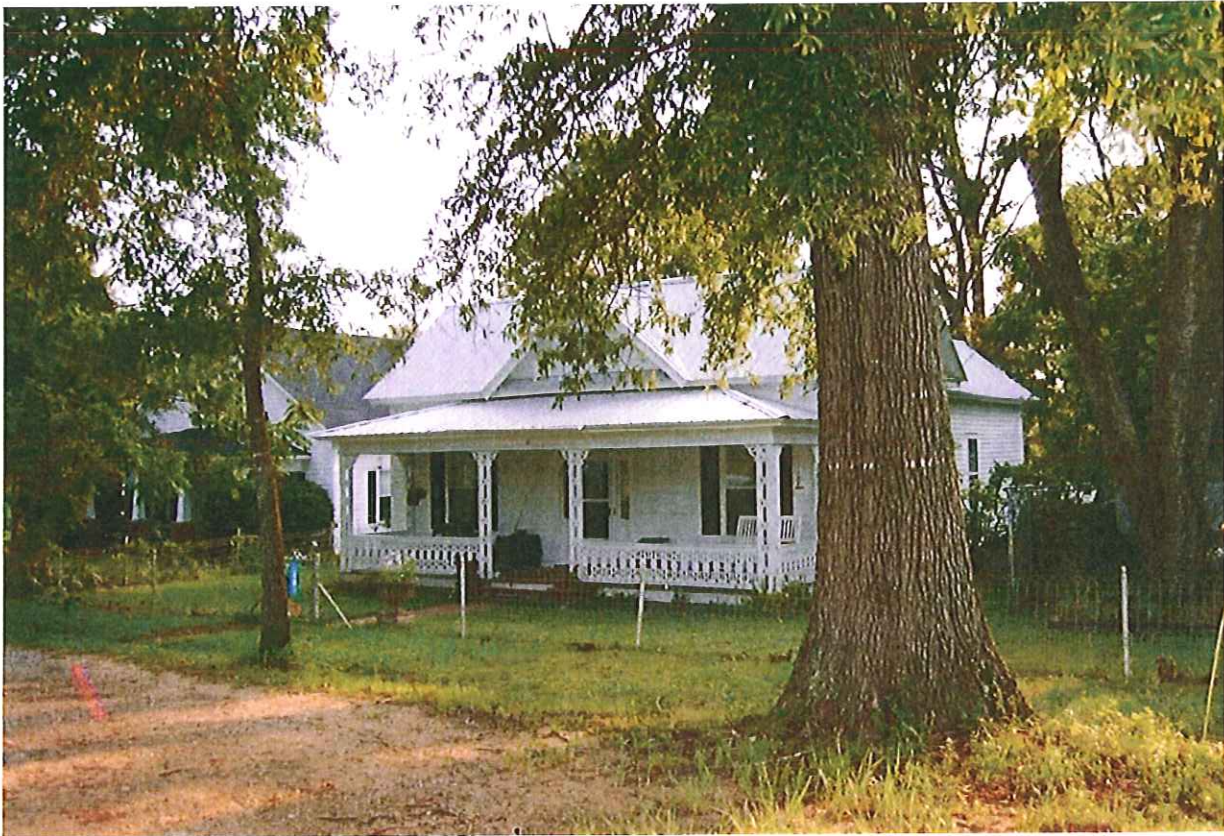
Historic Site: (BA Resource 17)

Description: Side-gable white house with standing seam metal roof; 6/6 d-h windows, sidelights and transom; scrollwork on porch

Distance from Line Route: 0.83 miles / 1.33 kilometers

Field Visit & Analysis: Heavy foreground and mid-ground screening; line route will not be visible.

Conclusion Based on the Visual Impact Assessment and Field Visit: No View

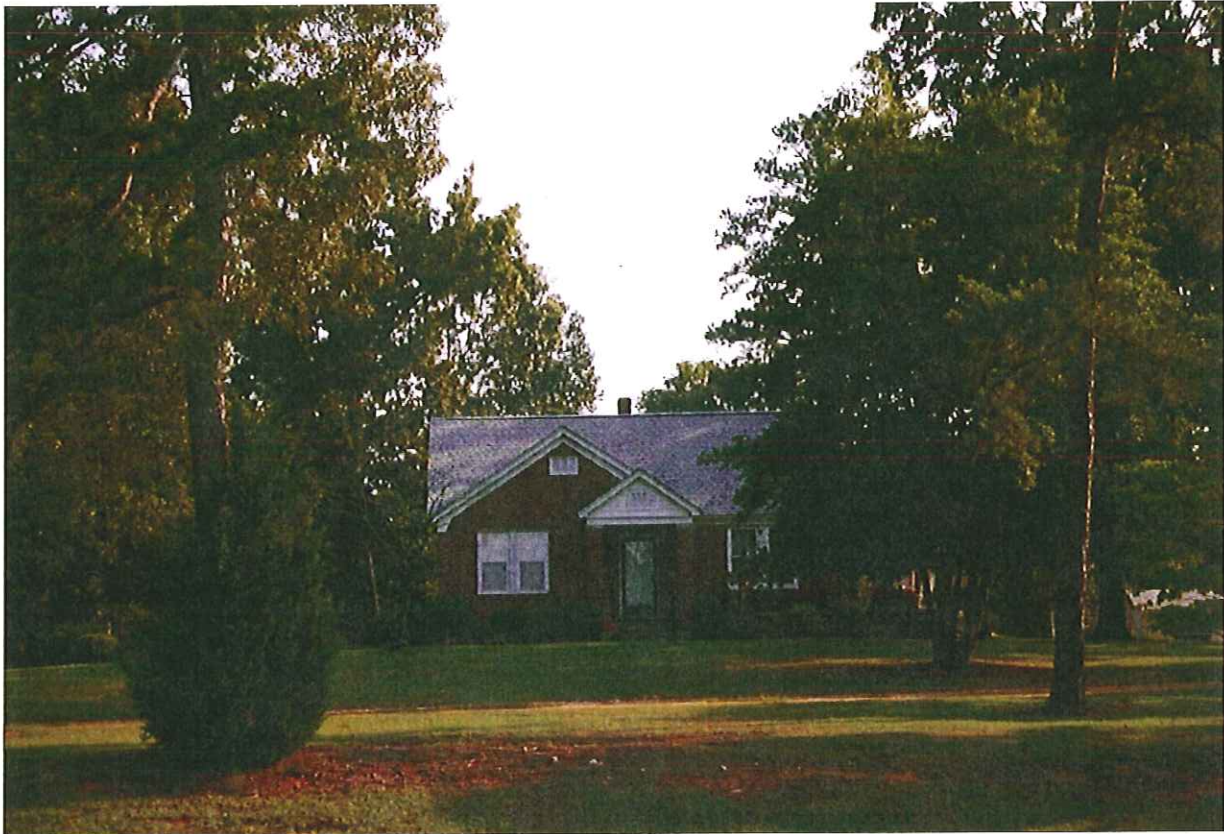
Historic Site: (BA Resource 18)

Description: Minimal tradition brick house, side-gable, interior chimney, 3/1 d-h windows, concrete foundation, asbestos siding, asphalt shingles

Distance from Line Route: 1.21 miles / 1.95 kilometers

Field Visit & Analysis: Heavy foreground screening; line route will not be visible.

Conclusion Based on the Visual Impact Assessment and Field Visit: No View

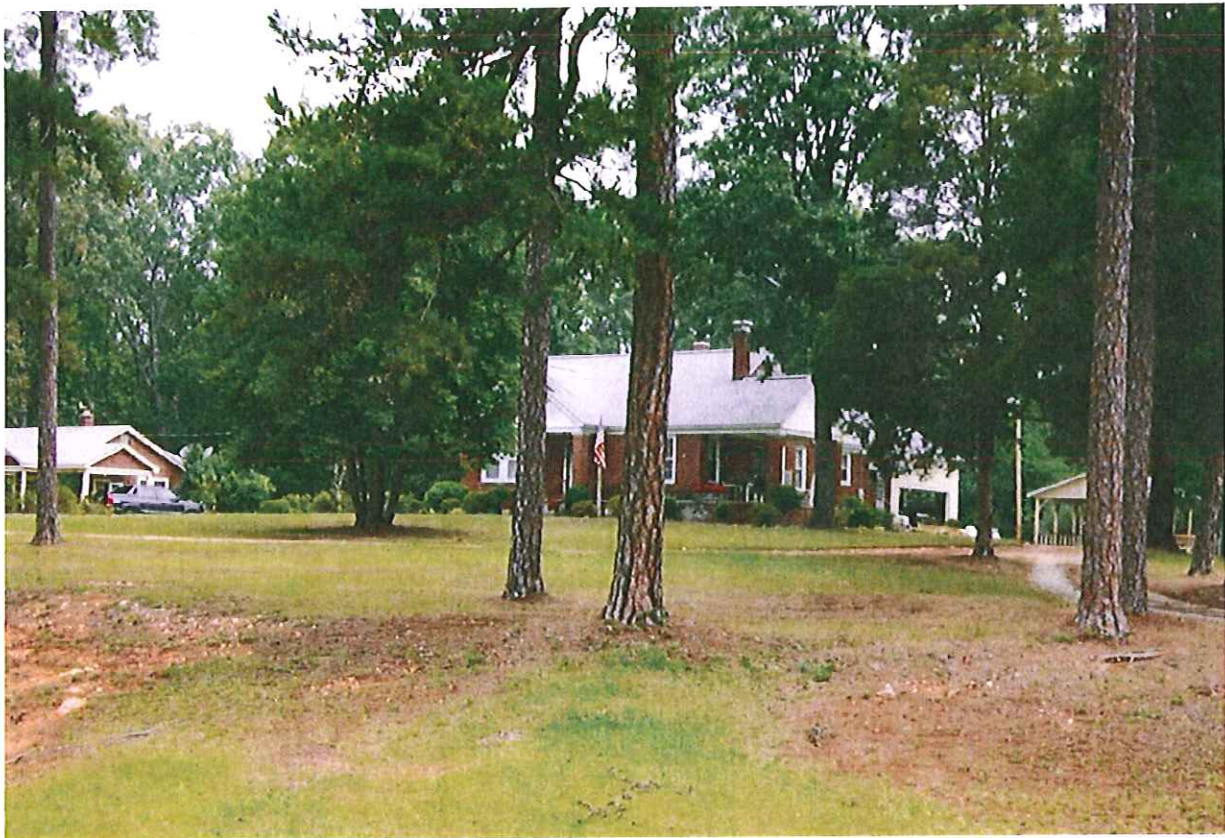
Historic Site: (BA Resource 19)

Description: Brick house w/Tudor characteristics; multi-gable roof; 3/1 d-h windows; brick columns; large rear addition

Distance from Line Route: 1.24 miles / 2.00 kilometers

Field Visit & Analysis: Heavy foreground screening; line route will not be seen.

Conclusion Based on the Visual Impact Assessment and Field Visit: No View

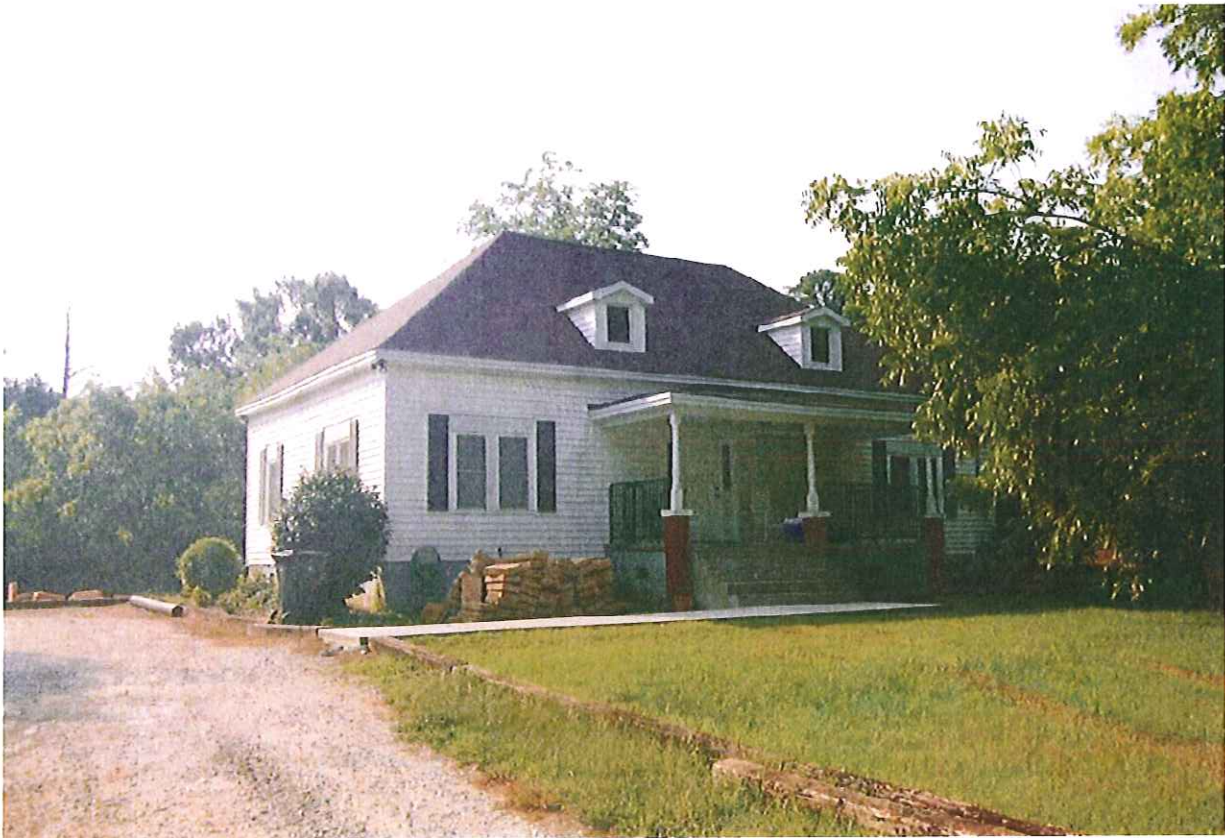
Historic Site: (BA Resource 20)

Description: Side-gable roof; front-gable porch w/wrought iron columns; 3/1 original windows; asbestos shingles; brick foundation (infill)

Distance from Line Route: 1.09 miles / 1.75 kilometers

Field Visit & Analysis: Light foreground and heavy mid-ground screening; line route will not be visible.

Conclusion Based on the Visual Impact Assessment and Field Visit: No View

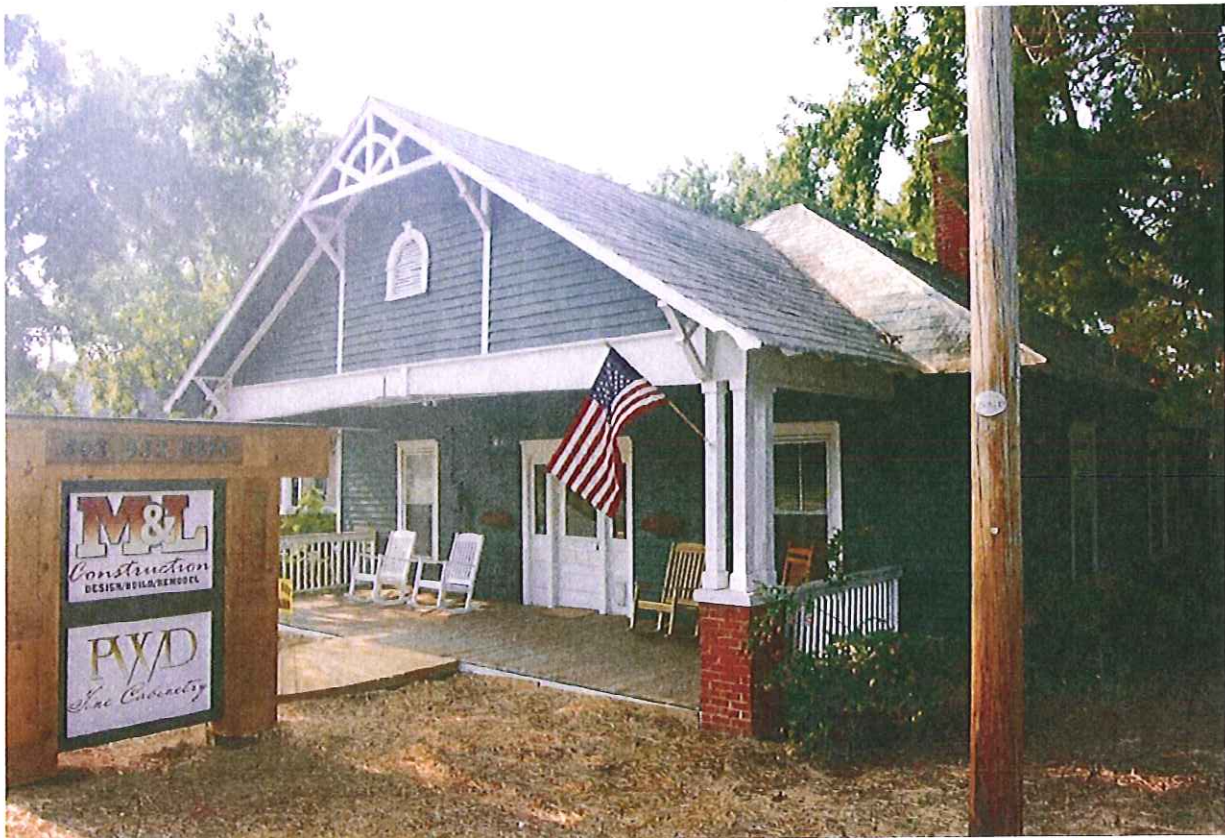
Historic Site: (BA Resource 21)

Description: (Occupied by Palmetto Wood Designs) Clapboard siding, hipped roof w/pressed tin, exterior brick chimney, curved rafter tails, brick piers foundation, sidelights

Distance from Line Route: 1.24 miles / 1.99 kilometers

Field Visit & Analysis: Heavy foreground and mid-ground screening; line route will not be visible.

Conclusion Based on the Visual Impact Assessment and Field Visit: No View

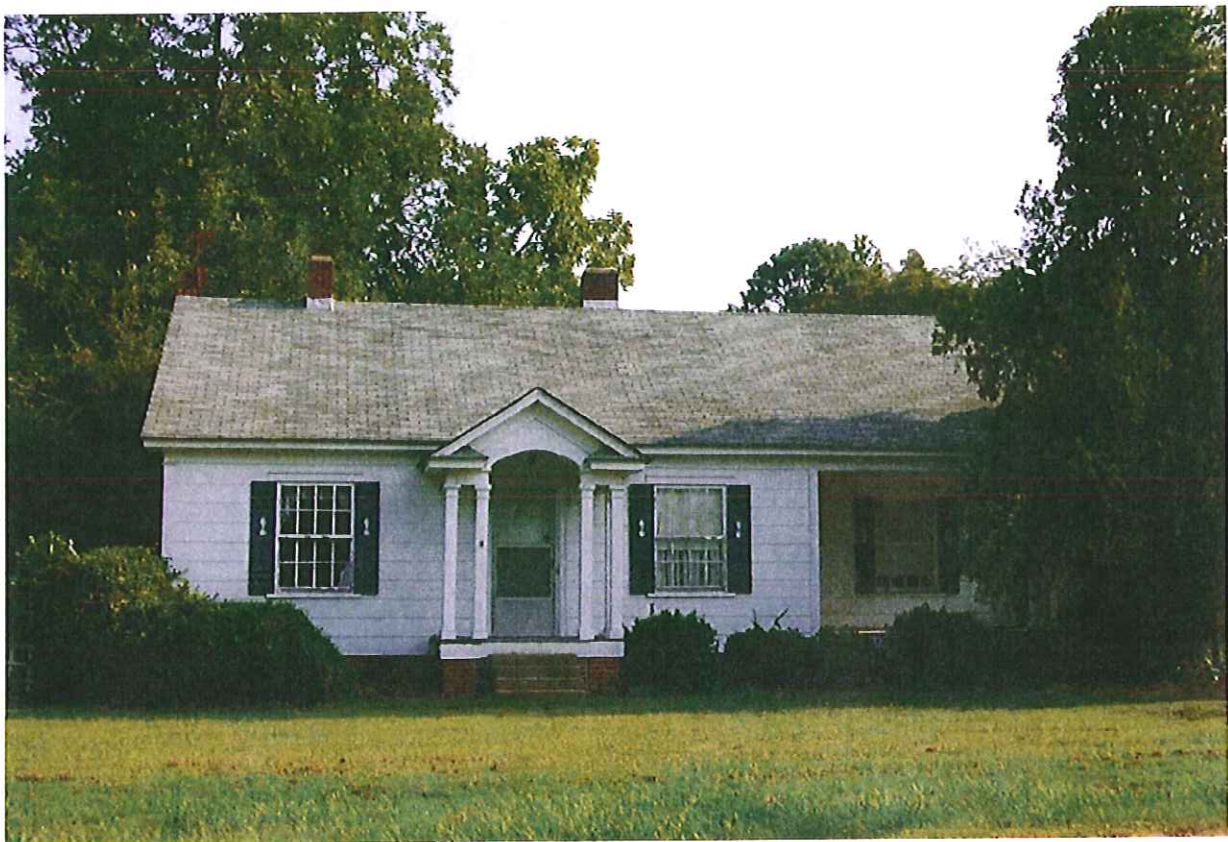
Historic Site: (BA Resource 22)

Description: White Minimal Traditional house w/ 2 interior brick chimneys

Distance from Line Route: 1.89 miles / 1.18 kilometers

Field Visit & Analysis: Heavy foreground screening; line route will not be visible.

Conclusion Based on the Visual Impact Assessment and Field Visit: No View

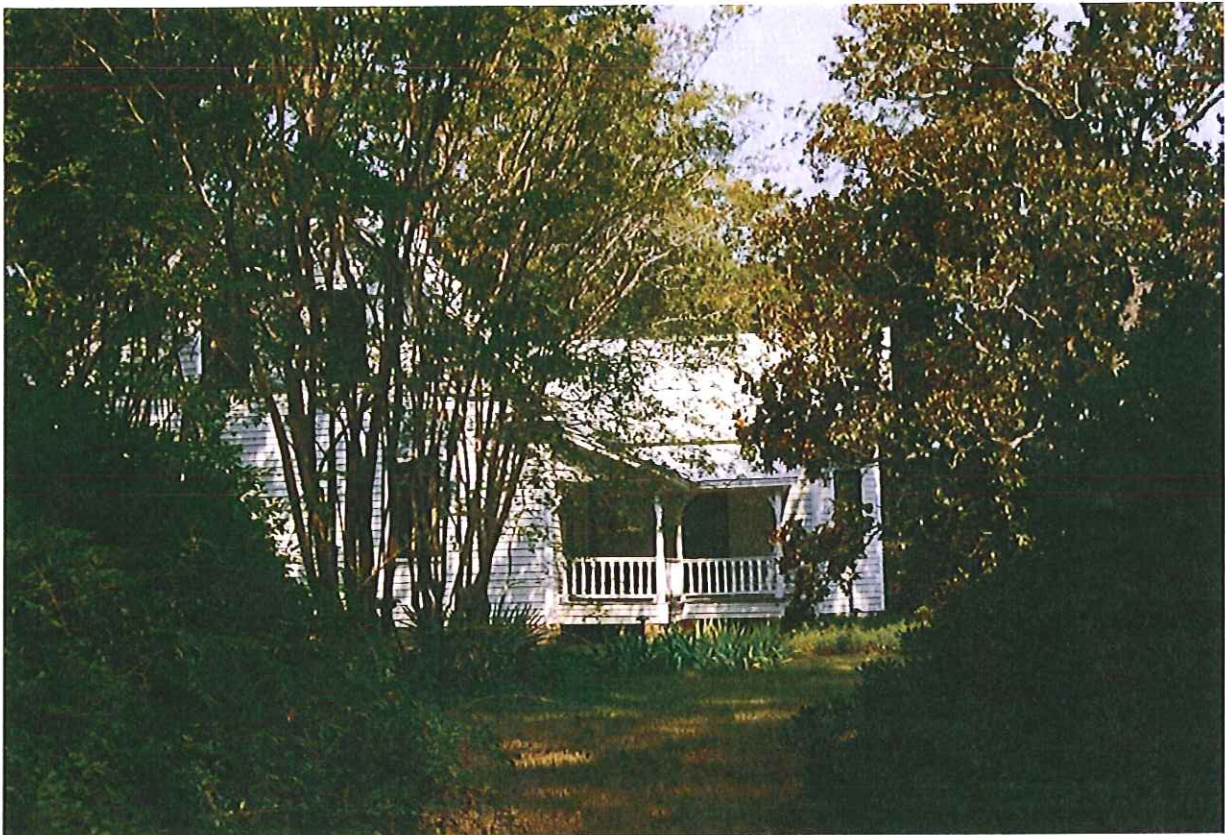
Historic Site: (BA Resource 32)

Description: Folk Victorian house w/ outbuildings; saw tooth shingles in gables

Distance from Line Route: 0.87 miles / 1.40 kilometers

Field Visit & Analysis: Heavy foreground screening; line route will not be visible.

Conclusion Based on the Visual Impact Assessment and Field Visit: No View

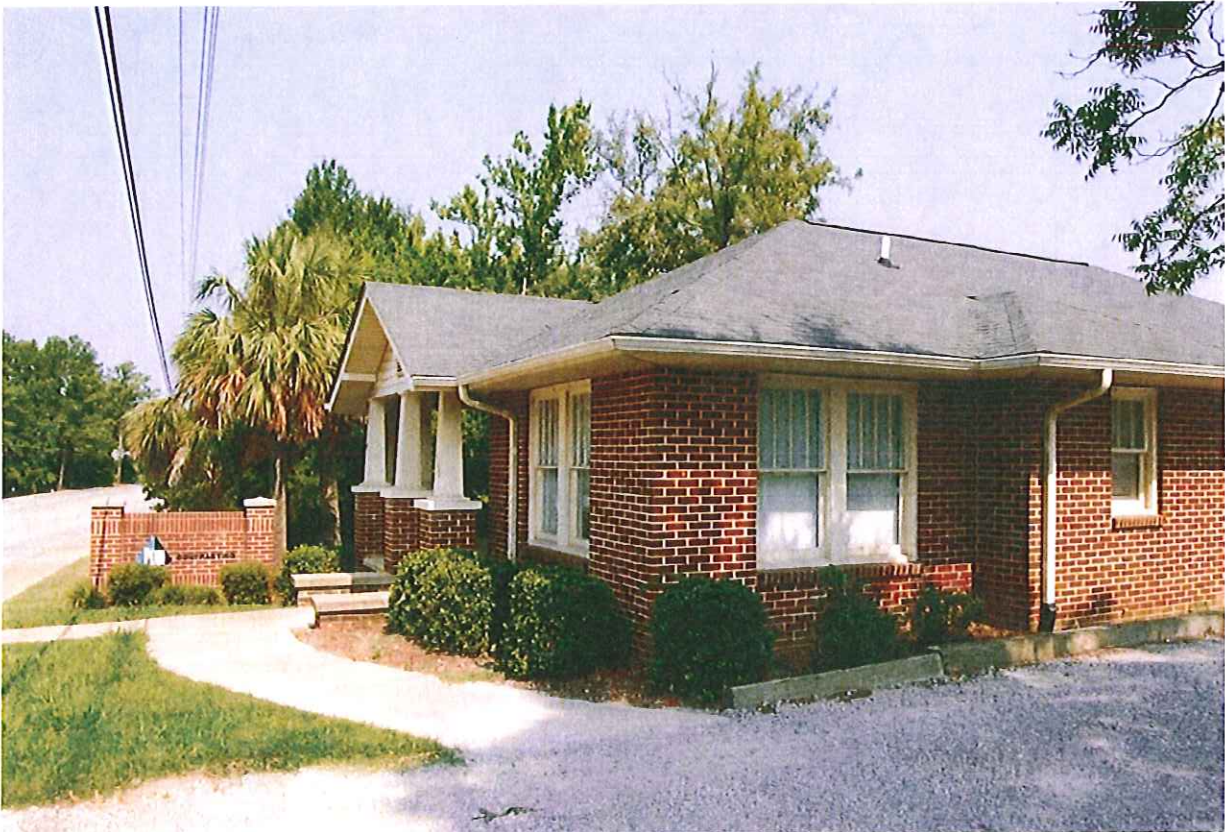
Historic Site: (BA Resource 34)

Description: Craftsman bungalow (occupied by Penn Contracting); battered piers on porch, 3/1 d-h windows, rear addition

Distance from Line Route: 0.82 miles / 1.32 kilometers

Field Visit & Analysis: Elevation difference and heavy foreground screening; line route will not be visible.

Conclusion Based on the Visual Impact Assessment and Field Visit: No View

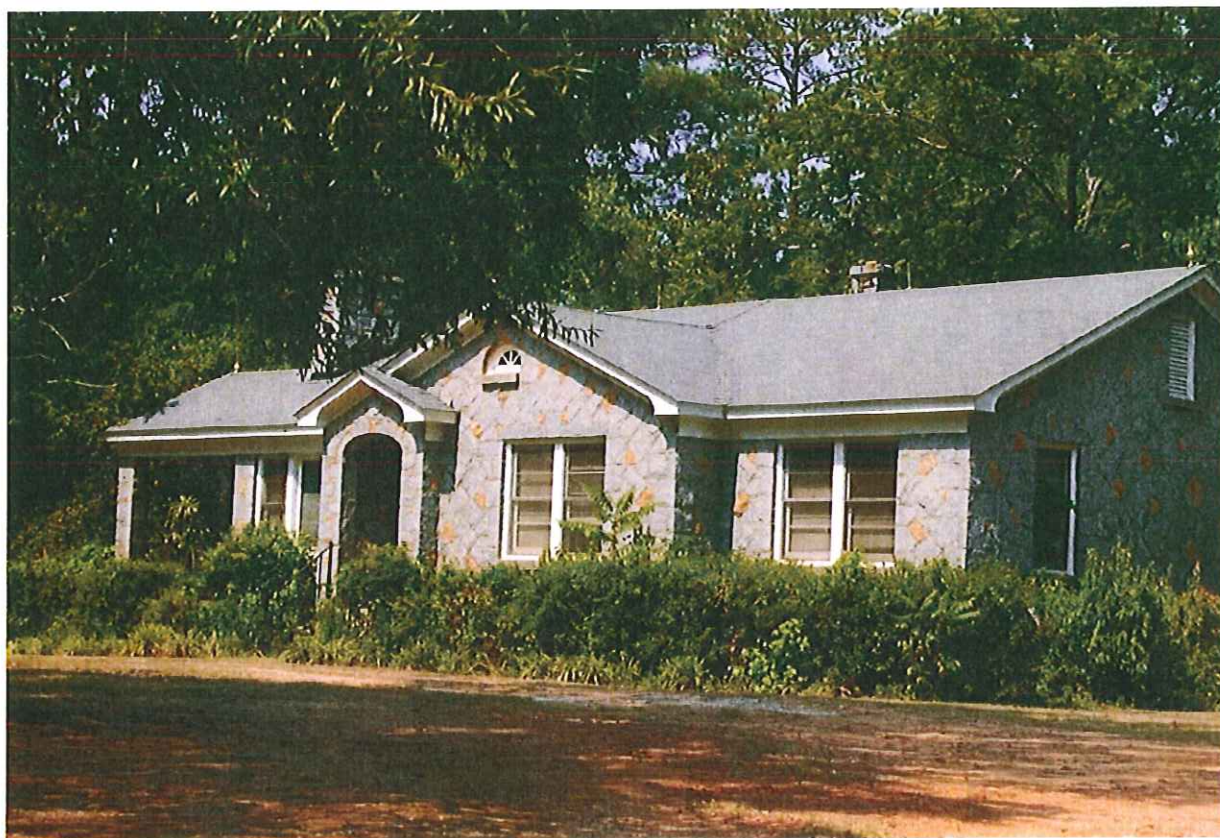
Historic Site: (BA Resource 42)

Description: Granite 1-story bungalow with Tudor characteristics; small fanlight in gable; exterior chimney, open side porch

Distance from Line Route: 1.09 miles / 1.76 kilometers

Field Visit & Analysis: Heavy foreground screening; line route will not be visible.

Conclusion Based on the Visual Impact Assessment and Field Visit: No View

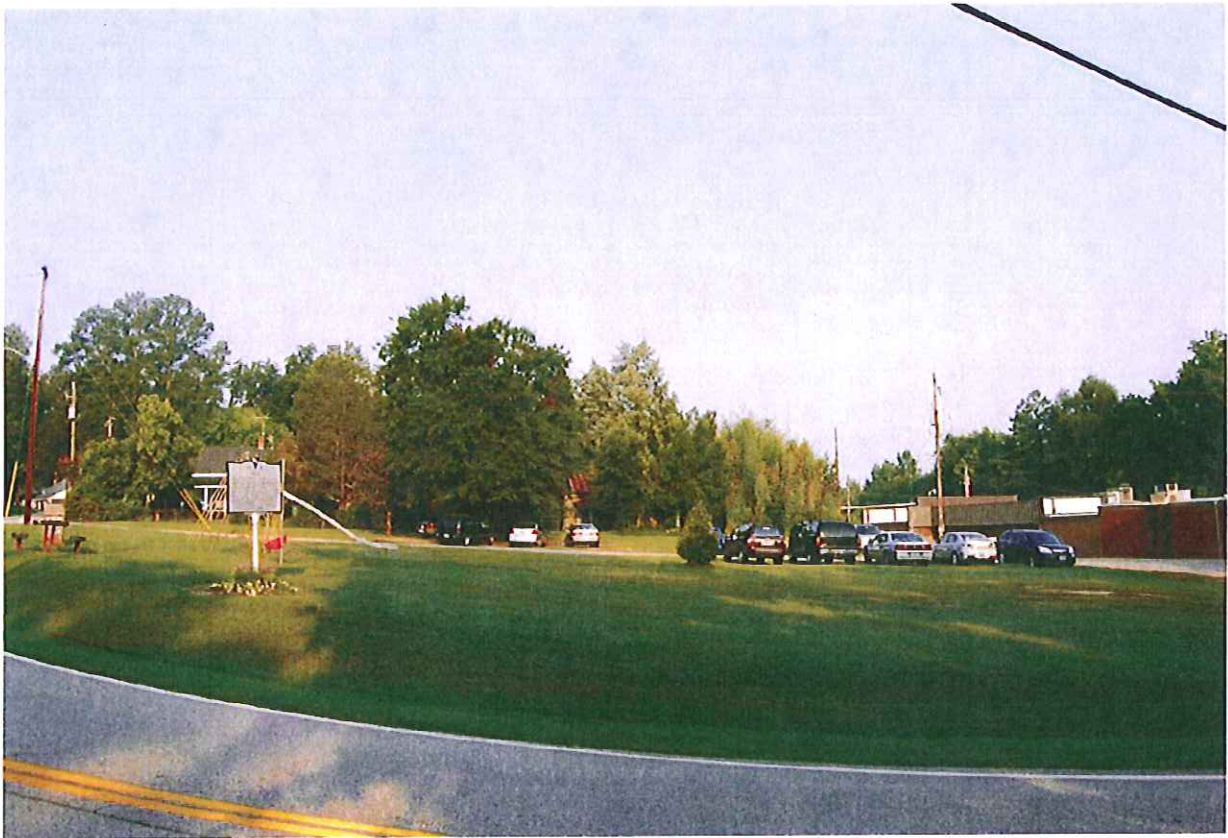
Historic Site: Town of Peak

Description: Mix of styles – mostly frame, vernacular houses

Distance from Line Route: 0.68 miles / 1.10 kilometers

Field Visit & Analysis: Heavy foreground screening; line route will not be visible from any point within the district.

Conclusion Based on the Visual Impact Assessment and Field Visit: No View
